APPLICATION OF COST EFFECTIVE CONDITION BASED MAINTENANCE & OVERHAULING PRACTICES IN NTPC

C.G. PORWAL

Deputy Manager (OS), NTPC, India

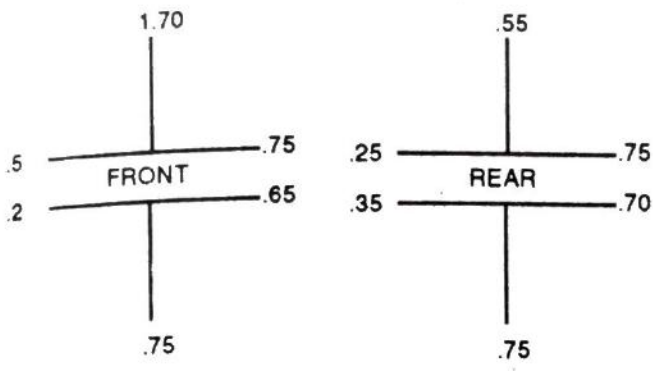
BEFORE CORRECTION

CASE 8 STATION SSTPS, 500MW UNIT VII

Maximum shaft vibration of the order of 140 microns was observed during commissioning of the unit. In fact shaft vibration was low at (49.35hz) i.e. 50 microns at 50 MW but it had tendency to rise with increase in load. The axial vibration at bearing no 4 also had similar tendency.

The axial vibration of the order of 120 microns and 18 mm/sec peak was observed at 270 MW load (49.37) HZ) and also sparking due to gland rubbing near LP rear gland noticed.

- i) LP gland seal clearance increased from .2/.3 to .5/.6 mm as shown below

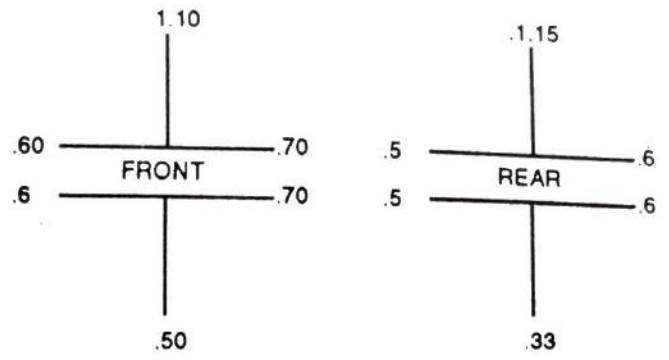
AFTER CORRECTION

RESULT AFTER ADJUSTING THE LP FRONT AND REAR GLAND CLEARANCES THE HPT FRONT AND REAR SHAFT VIBRATION REDUCED TO NORMAL I.E. 50 AND 12 MICRONS. THE AXIAL VIBRATION ALSO REDUCED TO NORMAL.

CONCLUSION : HPT FRONT AND REAR VIBRATION CAN BE AFFECTED BY INADEQUATE FRONT AND REAR GLAND CLEARANCES IN LP TURBINES.
