**SUB:- STUDY REPORT ON HIGH SHAFT VIBRATION PROBLEM OF
TURBINE GENERATOR OF RIHAND UNIT#4 (500 MW)**

**STUDY REPORT ON HIGH SHAFT VIBRATION PROBLEM
OF TG#4 (500 MW)
AT
RIHAND STPS [6x500 MW]**

**RIHAND SUPER THERMAL POWER STATION
NTPC LIMITED, RIHAND, (UP)**

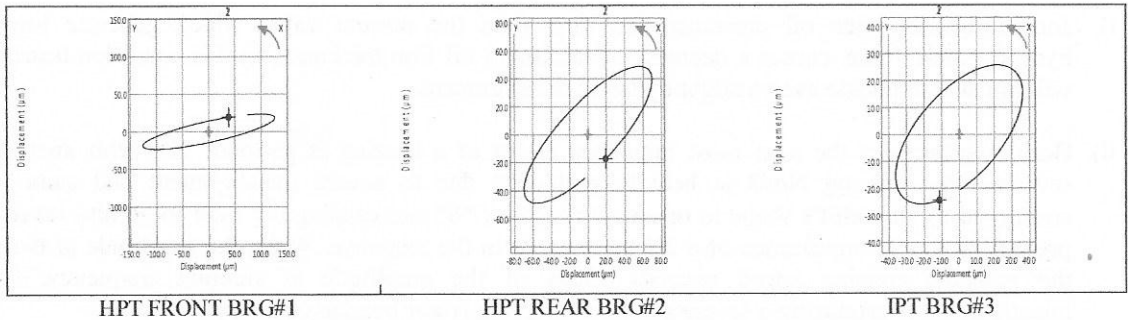
- v) Orbit analysis of HPT bearings indicates that vibrations are in forward precession whereas on IPT, it is under reverse precession which may be due to misalignment.

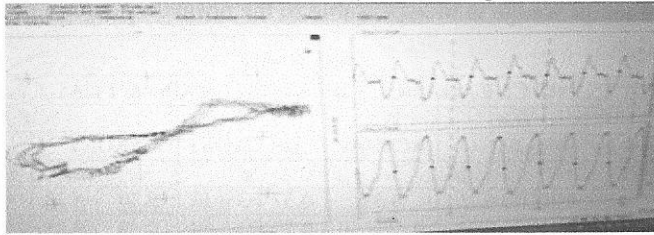
- vi) The Orbit plot taken during the load at 410 MW on 15th August 2019 indicated that Brg No 3 is highly preloaded, confirmed by orbit shape to resemble character "8" and causing the shaft to go into reverse precession due to appearance of a 2X component in the response.

Figure No 1 indicating higher amount of preload on the rotor which causes the orbit to become more elliptical and distorted. This is where the spring constant is much higher in the opposite direction to the pre-load than in the perpendicular direction to the preload. This produces the classical twice per rev frequency associated with alignment.

BRG No #3 Direct Orbit (Banana shape)

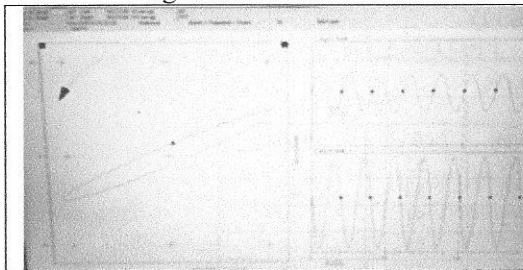
Figure No 2 (a)

- vii) A bearing preload due to cocked assembly can also cause orbit to have lower amplitude in one axis that makes the ellipse look thinner as shown in Figure 2(a). But heavy preloading due to misalignment can cause the shaft to go into sometime reverse precession; can be seen in Figure No 2(b). The forward precession is normal; reverse is not can be seen in full spectrum taken during load on 15th August 2019.

Brg No#3 1x Orbit

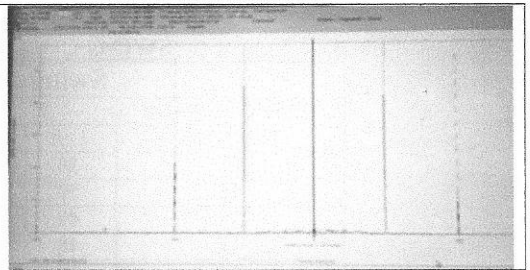
Figure No 2 (b)

Reverse Precession

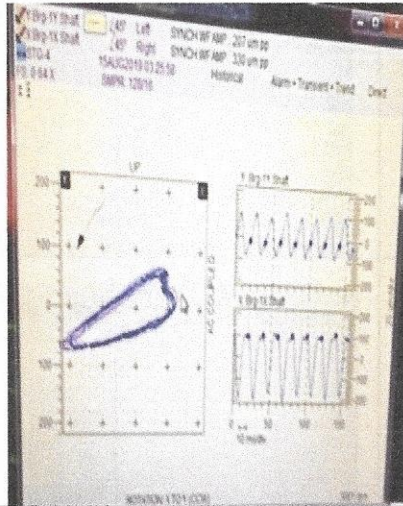
Overall vibration orbit

- viii) An Orbit analysis of HPT bearings indicating truncation in the orbit which is an effect of misalignment.
