APPLICATION OF COST EFFECTIVE CONDITION BASED MAINTENANCE & OVERHAULING PRACTICES IN NTPC

C.G. PORWAL

Deputy Manager (OS), NTPC, India

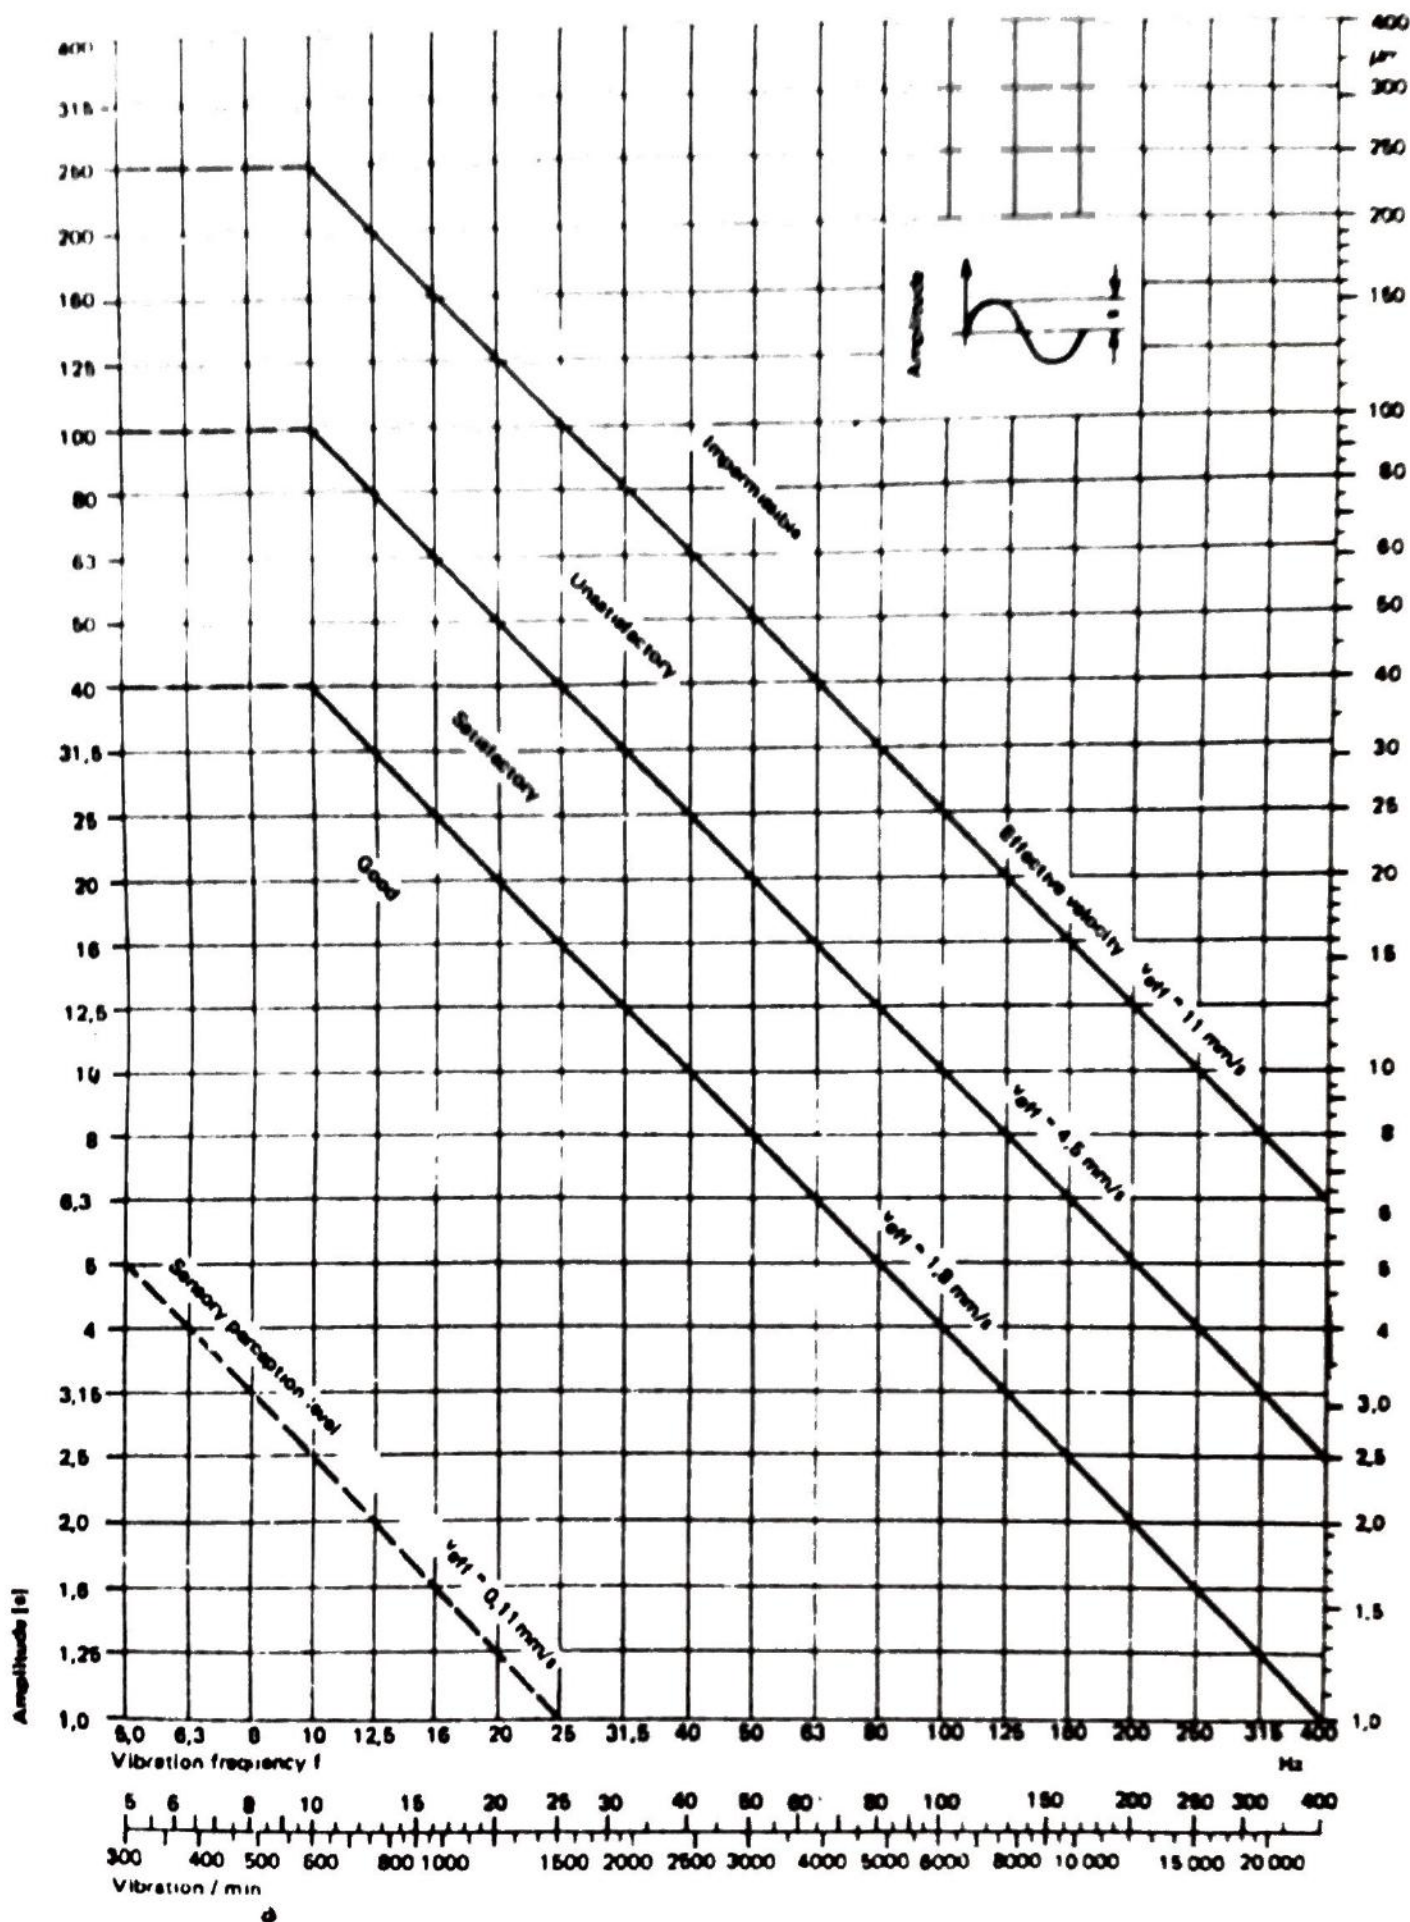
* **Turbines on high-tuned rigid and heavy foundations fig. no. 1**

Fig. 1 Limiting vibration characteristics for turbojets mounted on high tuned heavy foundation

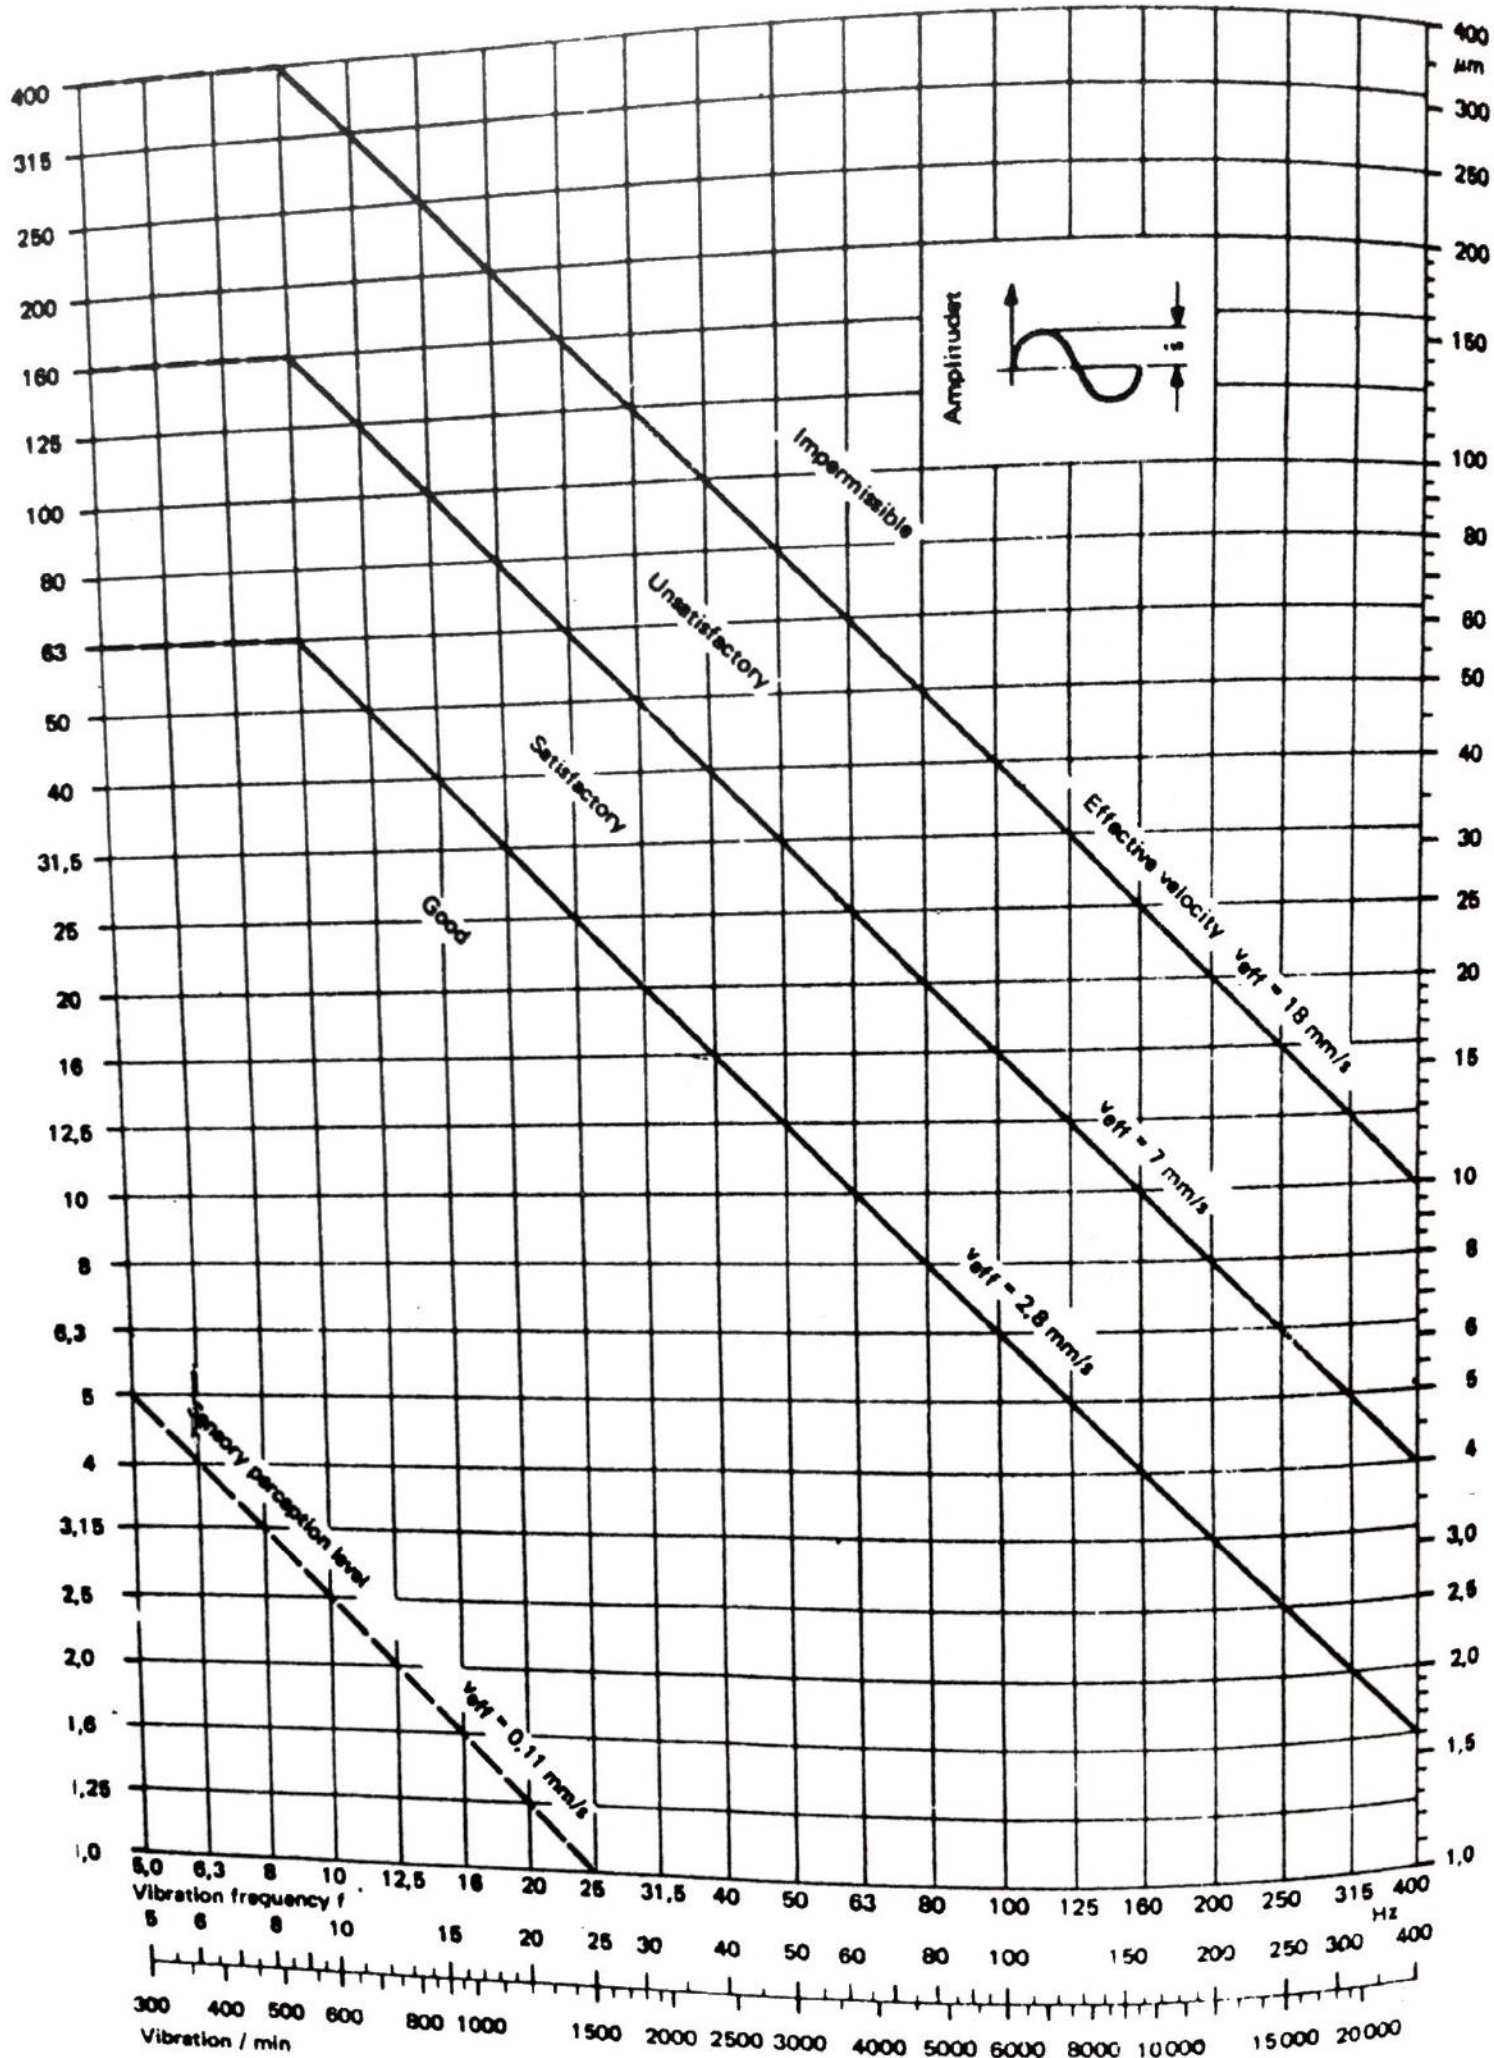
* **Turbines on low tuned light concrete or steel foundations fig. no. 2**

The design of the turbine foundations is such that assessment should be according to chart **fig. no. 2**. The maximum root-mean square velocity of bearing vibration in the turbine during steady-state operation should lie on the line of division between the good and serviceable ranges.

Fig. 2 Limiting vibration characteristics for turbosets mounted on low tuned light foundation

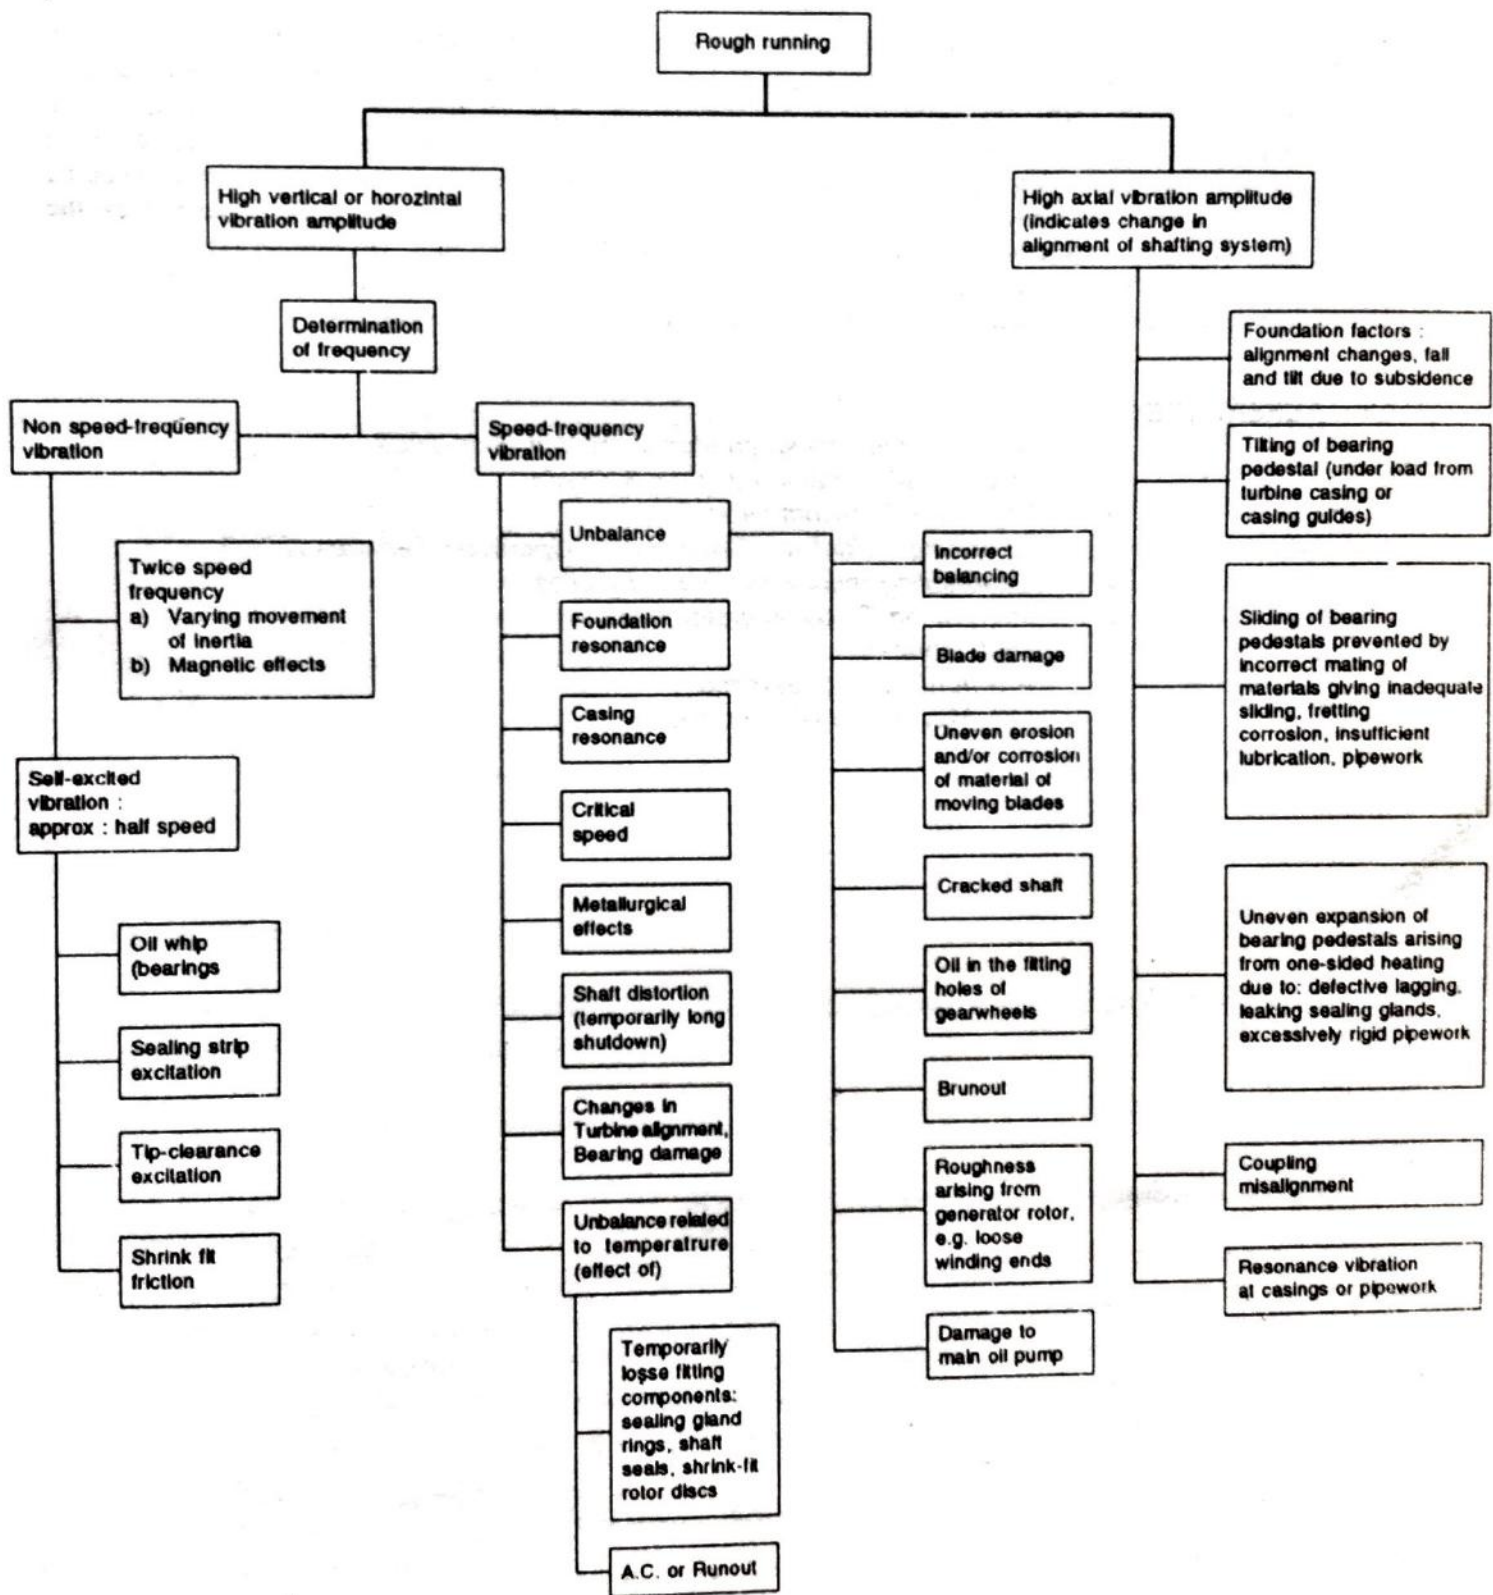
Fig. No. 3

- * If it is definitely discovered that the increased vibration is of low frequency (vibration frequency < rotational frequency). it is usually sufficient to reduce load on the machine until the vibration dies away.
- * Increase in vibration above normal values, but not exceeding the limit values, can also be assumed to be due to physical changes but these usually allow tests to be carried out to determine the cause of the condition. Such tests involve the determination of the vibration characteristics and intensity by means of measuring equipment independent of the operational measuring devices wherever possible. *It is advisable to measure;- Frequencies, amplitude intensity (H.V.A.) and phase angle and its change. The diagram in Fig no 3 gives general summary from various sources of well known possible causes of rough running of turbines.*

CAUSES OF EXCESSIVE VIBRATION
