**SUB:- STUDY REPORT ON HIGH SHAFT VIBRATION PROBLEM OF
TURBINE GENERATOR OF RIHAND UNIT#4 (500 MW)**

**STUDY REPORT ON HIGH SHAFT VIBRATION PROBLEM
OF TG#4 (500 MW)
AT
RIHAND STPS [6x500 MW]**

**RIHAND SUPER THERMAL POWER STATION
NTPC LIMITED, RIHAND, (UP)**

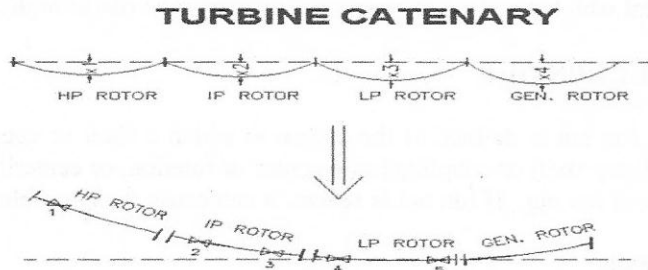
- ✓ When rotors are resting in free condition on their bearings, there will be individual sags in them due to its dead weight and dimensions.
- ✓ Due to above the mating coupling faces of the rotors shall be at an angle. In this condition it is very difficult to couple the rotors.
- ✓ To align the coupling faces the rotors are given vertical adjustment through bearing or pedestal adjustment so that they become parallel and coupling becomes easier. One rotor normally LP rotor is kept as MASTER.
- ✓ From above adjustment the deflected lines of rotors also approaches the Center line which reduces the Centrifugal forces on the rotor.

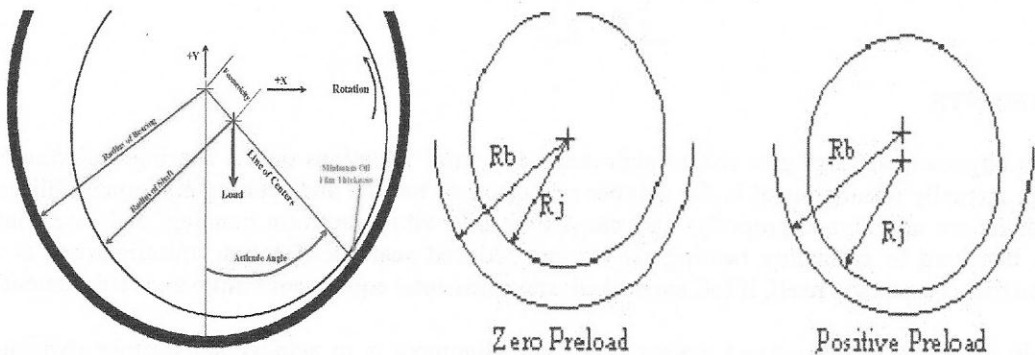
Besides clearance the next most important factor of a bearing is preload. A preloaded bearing simply means that the centre of curvature of the pad is not coincident with the geometric center of the bearing. Preload can be thought of as the percentage of clearance reduction. A preload is defined as a directional load or force applied to the rotating shaft. Preloads can be defined into two basic categories, external and internal.

External Preloads: Only one type of external preload exists. This is one whereby the directional force is applied to the rotating shaft through the coupling element. This is caused by angular or parallel misalignment, plus a stuck or partially stuck coupling. The magnitude of this preload is a function of the amount of misalignment as well as the type and condition of the coupling, the highest existing for a rigid shaft, and the lowest with diaphragm or other spring type couplings.

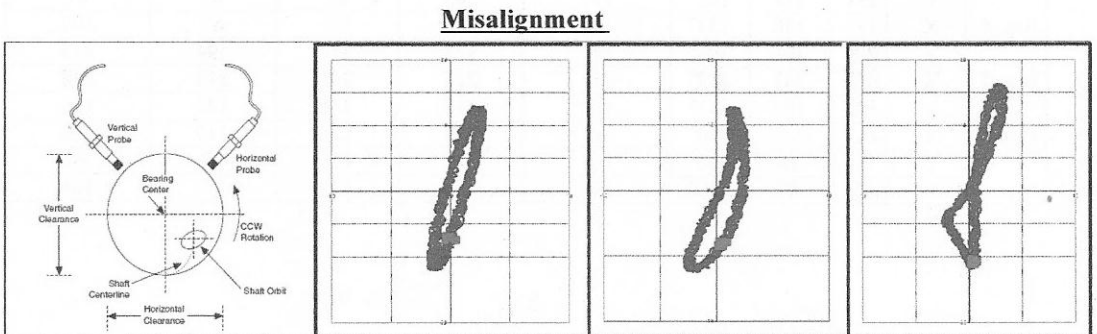
An orbit measurement is taken with a pair of proximity probes (non-contact probes), mounted radially, 90° apart (or as near as is practical). Typically, the probes are mounted at ±45° as shown below. The orbit display shows a single trace which illustrates how the shaft moves within the bearing as it rotates, in the style of a Lissajous figure. Both filtered and unfiltered orbits can be viewed.

---Increasing Severity of Misalignment----->
